REPORT NO: MT-17/893-A

LOAD TESTING OF A 14" PARALLEL POOL GRATE FOR CLASS A

CLIENT: **DALDORADO**
ATTENTION: ROBERT LAWSON
5/99 HUMPHRIES ROAD
FRANKSTON SOUTH VIC 3199

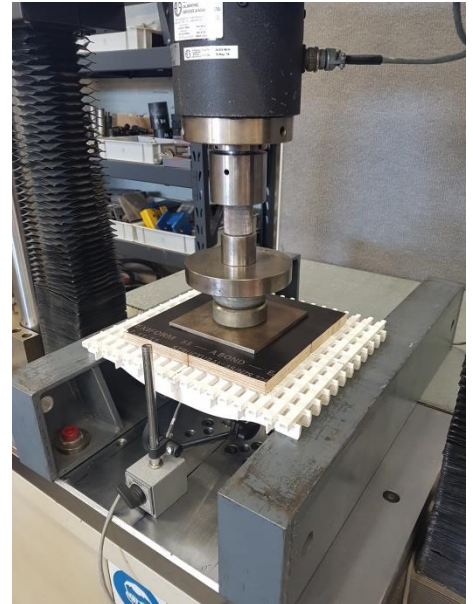
**FIG. 2
GRATE TEST SET-UP**

The access cover grate was aligned centrally under the actuator of a calibrated universal testing machine (UTM). The grate was rigidly supported on two (2) parallel edges with a free span of 292 mm to replicate the bearing conditions typically seen in service (see Fig. 2). A series of displacement transducers was used to measure the net deflection at the centre of the cover throughout testing. All compressive test loads were applied vertically to the centre of the cover grate via a 240 × 240 mm square loading platen. Test load and deflection were recorded autographically during testing using a computerised data acquisition system.
