REPORT NO: MT-17/893-B

LOAD TESTING OF A 14" PERPENDICULAR POOL GRATE FOR CLASS A

CLIENT: **DALDORADO**
 ATTENTION: ROBERT LAWSON
 5/99 HUMPHRIES ROAD
 FRANKSTON SOUTH VIC 3199

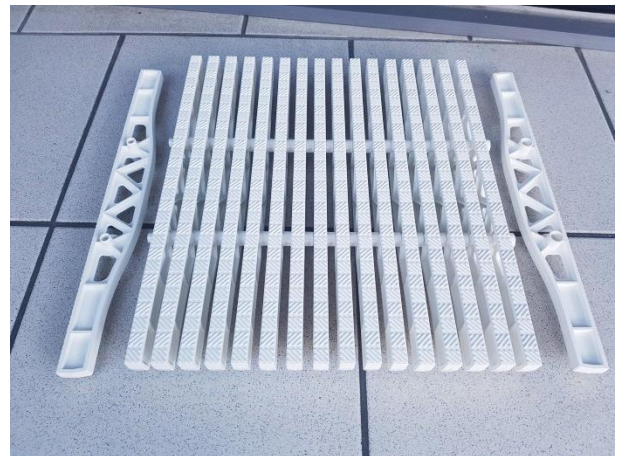
FIG. 1
'PERPENDICULAR' POOL GRATE
COMPONENTS AS DELIVERED

<i>Specimen I.D.:</i>	'Perpendicular' Grate
<i>Grate Width:</i>	355.6 mm (14")
<i>Assembled Length:</i>	304.8 mm (12")
<i>Material:</i>	PVC
<i>Module Members:</i>	355.6 × 38 × 12 mm sections
<i>Module Spacing:</i>	20 mm centres
<i>Module Connectors:</i>	Two (2), Ø10 mm socket/spigot pairs per member at 115 mm centres
<i>Circular Opening (CO):</i>	292 mm

Interlocking modular pool grate members were delivered to the MTS laboratory for load testing (see Fig. 1). At the request of the client, DALDORADO, the components were to be assembled to a 12" length and Type Tested for **Class A** in accordance with AS 3996 — 2006 ACCESS COVERS AND GRATES; CLAUSE 4.2.1.2 and APPENDIX C. Following testing to AS 3996, the assembly was to be loaded until failure in order to determine the ultimate strength capacity of the specimen.

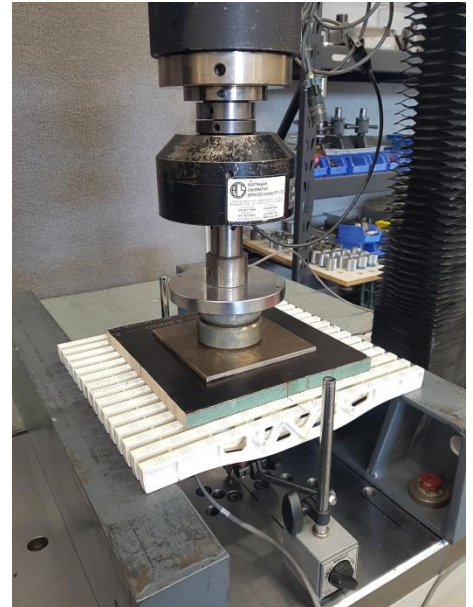
The assembled access cover grate was aligned centrally under the actuator of a calibrated universal testing machine (UTM). The specimen was rigidly supported on two (2) parallel edges with a free span of 292 mm to replicate the bearing conditions typically seen in service (see Fig. 2). A series of displacement transducers was used to measure the net deflection at the centre of the cover throughout testing. All compressive test loads were applied vertically to the centre of the cover grate via a 240 × 240 mm square loading platen. Test load and deflection were recorded autographically during testing using a computerised data acquisition system.

**FIG. 2
GRATE TEST SET-UP**
