# **TEST REPORT**

**Report Number:** 2505-18003 **Project No.:** 29544

Sample Description: Suction fittings model no. DMD-FG-2424 (24" by 24" frame) installed in a field

**Scope of Testing:** The purpose of the testing was to determine if the sample tested suction fitting

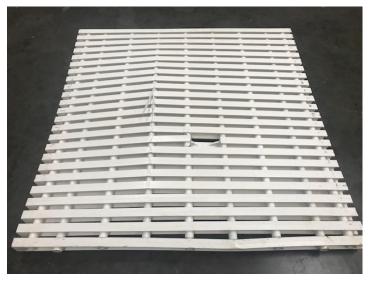
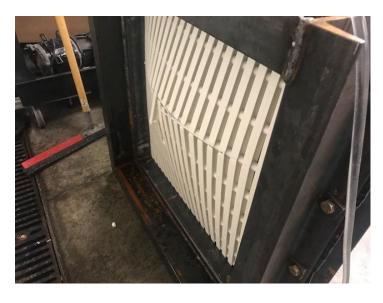
Pressure Differential and Point Impact Test Result for Suction fittings model no. DMD-FG-2424 (24" by 24" frame)

Findings: The cover did not remain in place. The fitting did have permanently deformation, crack, and lose of material from the fitting. Before the differential pressure of 16.2 psi,

cracked with lose of material. See Figure 2 for test results details.
