## **TEST REPORT**

Report Number:	2505-18005				
Report Issued:	December 19, 2018	Project No.: 31424			
Client:	DALDORADO				
	4327 Arnold Ave				
	Naples FL, 54104				
	Contact: Ray Vaughn				
Source of Samples:	rce of Samples: The unit was shipped to IAPMO R&T Lab from Daldorado and was received				
	prototype on December 14, 2018				
Location of Testing:	lampo R&T Lab, 5001 East Philadelphia Street, Ontario CA 91761				
Datas of Evoluation	December 17 <sup>th</sup> December 10 <sup>th</sup> 2018				
Dates of Evaluation:	December 17 - December 19 2018				
Product Description:	Current Flow Fitting Wall 300 gpm with $4^{\prime\prime}$ pipe connection for the inlet and 2				
	slits (10"x0.25"each) for the outlet.				
Primary Standard:	Manufacturer scope of work				
Scone of Evaluation:	Elow testing at 200, 250 and 400 gpm, proceure drop across f	itting face and			
	velocity calculation.				
Conclusion:	the scope of evaluation. Please refer to the following pages	s for details.

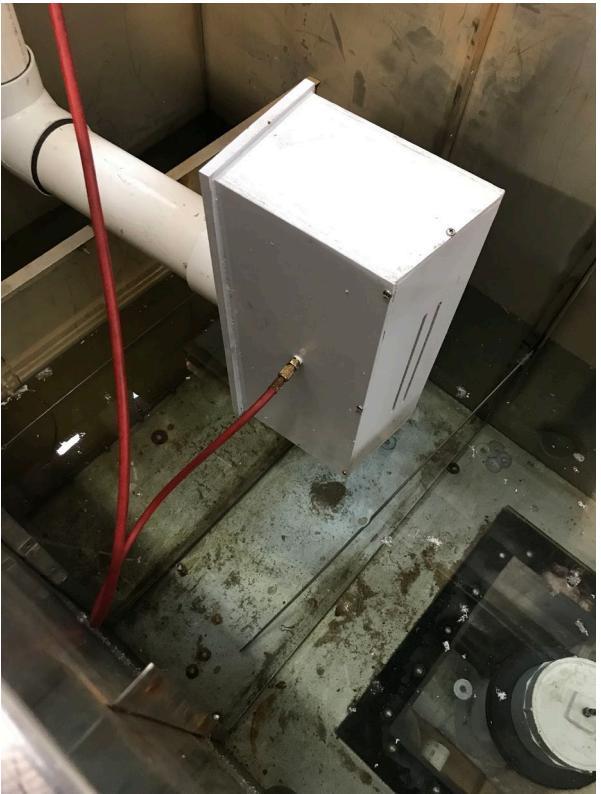
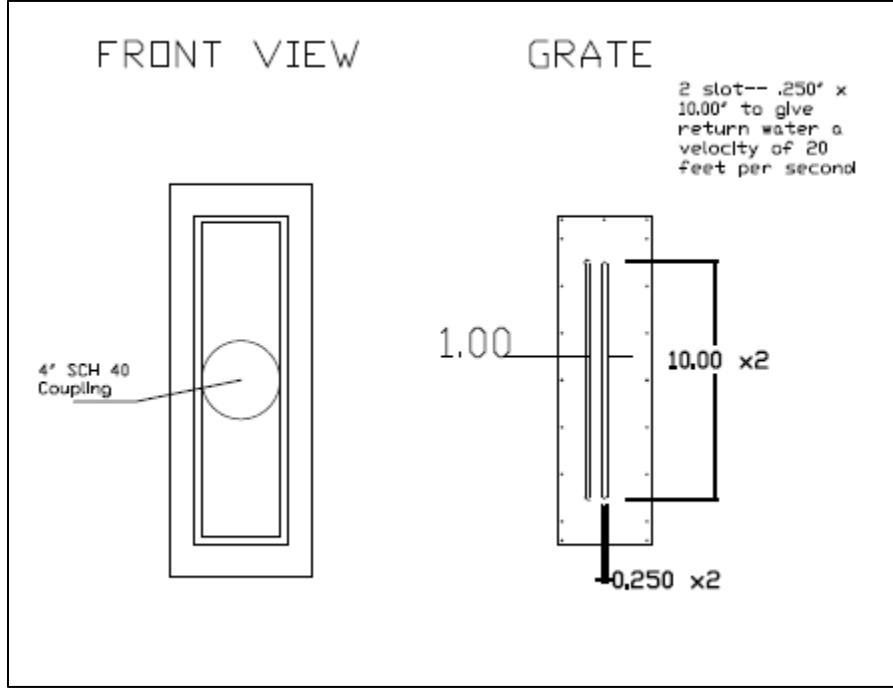
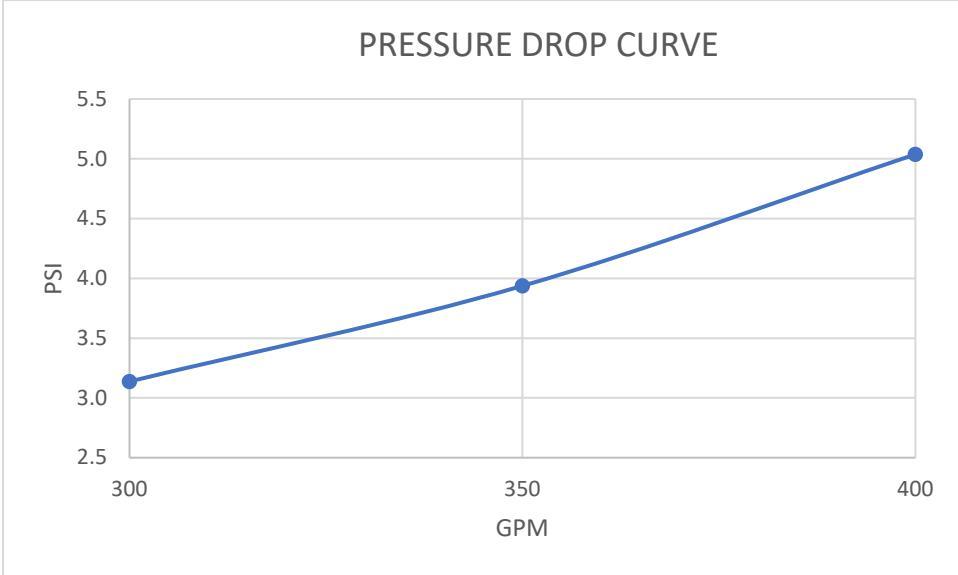
## Figure 1- Sample setup

The sample was placed in a tank and connected to a 4" Schd 40 PVC pipe to a pump and flowmeter. A tap was placed in the center side of the sample and connected to a pressure gage placed 29 inches above the tap. The water level was 14.125 inches above the tap. (see Figure 1).
